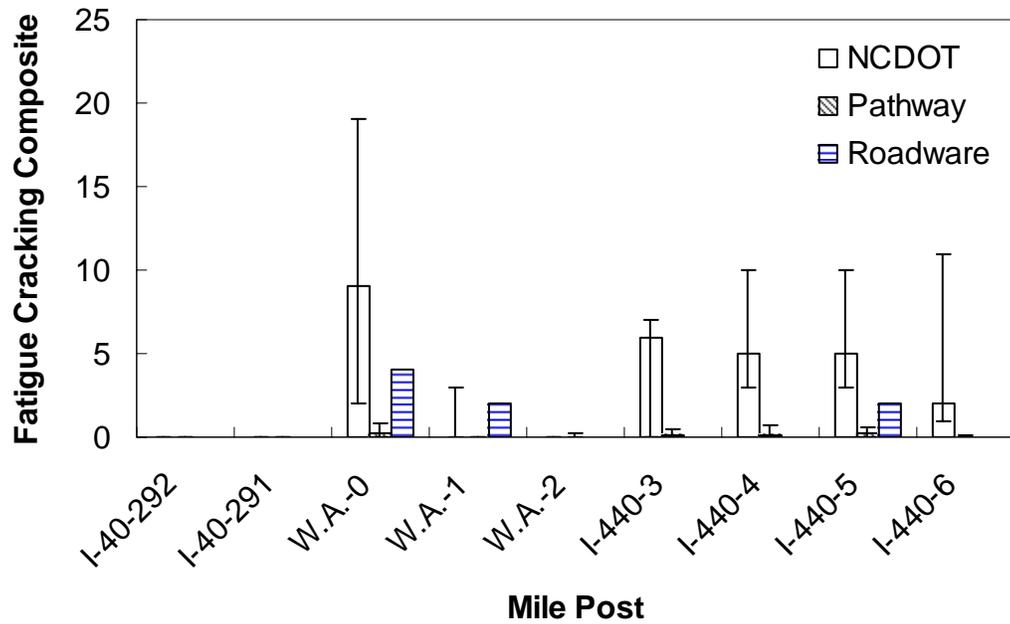
Figure 3.2. Fatigue cracking composite index for I-40, Wade Avenue, and I-440 sections.

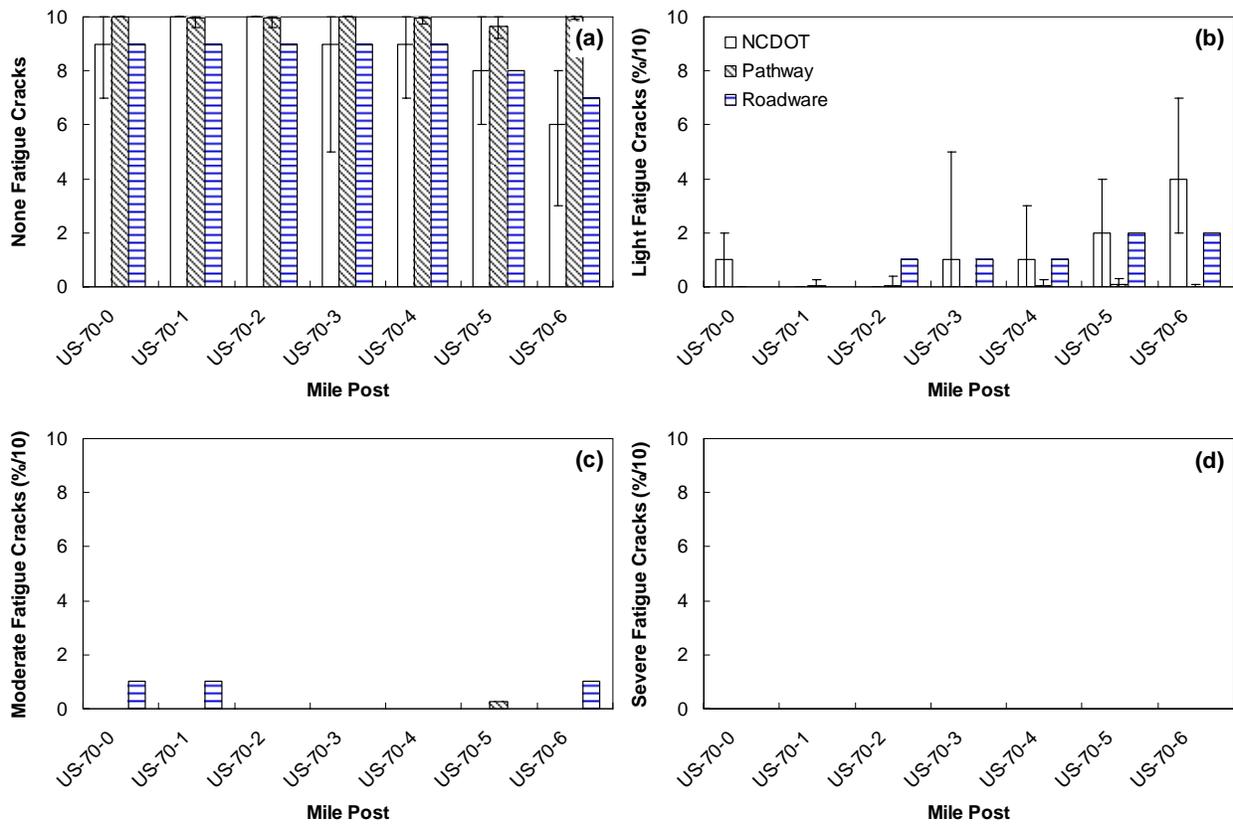
Figure 3.3. Fatigue cracking results for US-70 sections; (a) none rating, (b) light rating, (c) moderate rating, and (d) severe rating.
